2021

Case Study Series

Local Best Management Practices in Agriculture

Best Management Practices and Alternative Land Use Services in Grey, Bruce, and Huron Counties

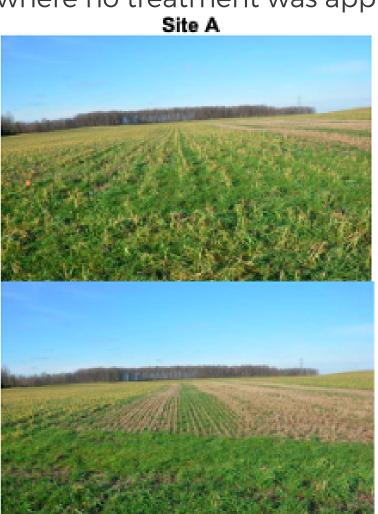
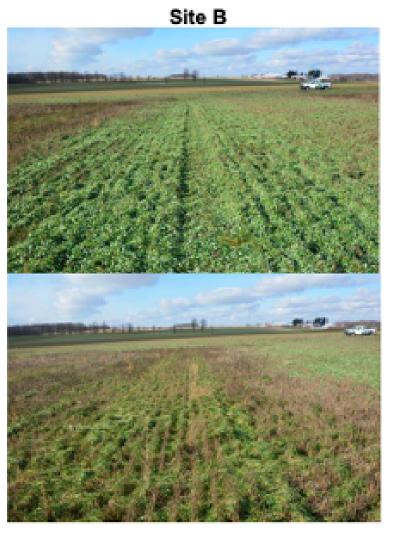
Caption: Cover crop application between the two sites.

The project team worked to develop a methodology that would test the objective of determining if cover crops could help to alleviate the effects of soil compaction. Based on this approach, a comparison of a worst-case versus a best-case scenario was implemented to showcase results. Trials were set up with two replicates of a fully compacted area and two that had normal field traffic. Cover crop treatments were then applied to each site, monitored and compared with the sites where no treatment was applied.
